Technical Report EL-94-15
October 1994

Reliability, Availability, and Maintainability Testing of High Pressure Pumping Units for Mobile Army 600 Reverse Osmosis Water Purification Unit

by Wayne W. Sharp, Howard K. Bell Consulting Engineers, Inc.

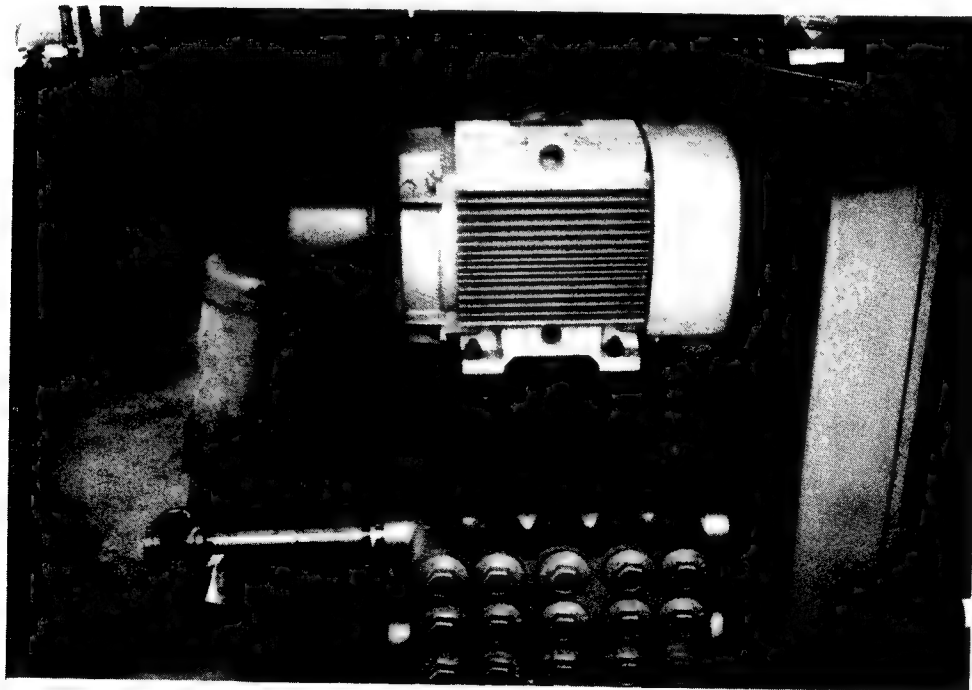
Figure 3. Wheatley quintuplex pump

- (1) Pump was disassembled easily in accordance with the manufacturer's off-the-shelf manual.
- (2) Fluid end was free of standing water.

- (3) Internal materials appeared in good condition, and all parts including the crankshaft were easily accessible.
- (4) Valves, packings, crankshaft, belt, coupling, driver, and pump exterior were in good shape.
- (5) Bearings were burred and scratched. Metal shavings were observed in the oil reservoir and removed with a magnet.

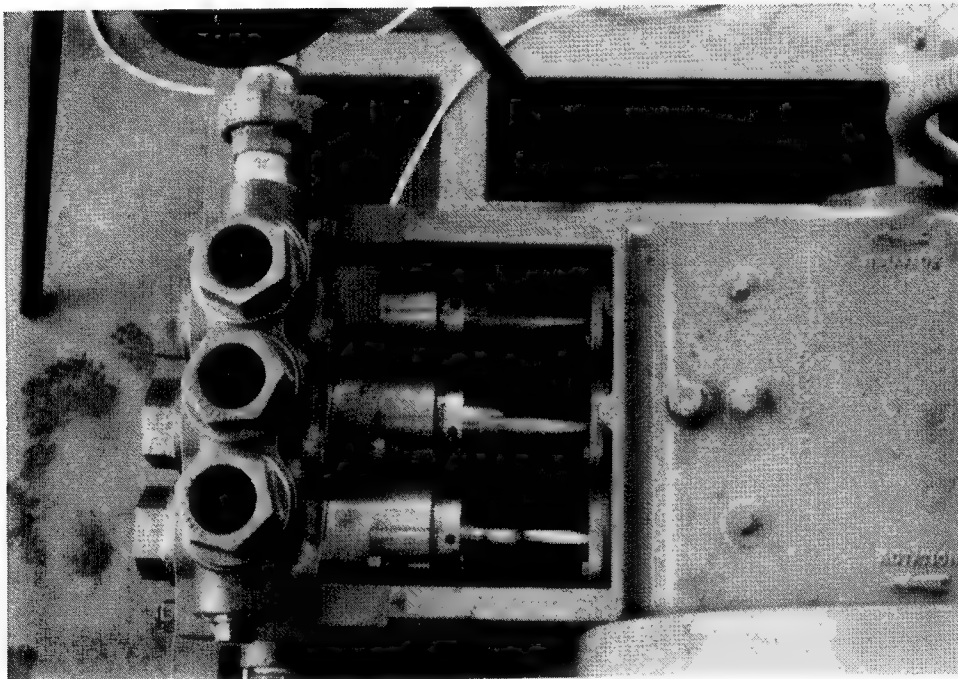
Figure 4. Union pump fluid end

- (1) Pump was disassembled easily in accordance with the manufacturer's off-the-shelf manual.

- (2) Rust was forming on cast iron surfaces around plunger on the liquid end of the pump.
- (3) Water was retained in the liquid end of the pump even with plug extracted.
- (4) Rust was forming on valves, couplings, driver, and on the exterior of the pump.
- (5) Packings, crankshaft, and belts appeared to be in good condition.

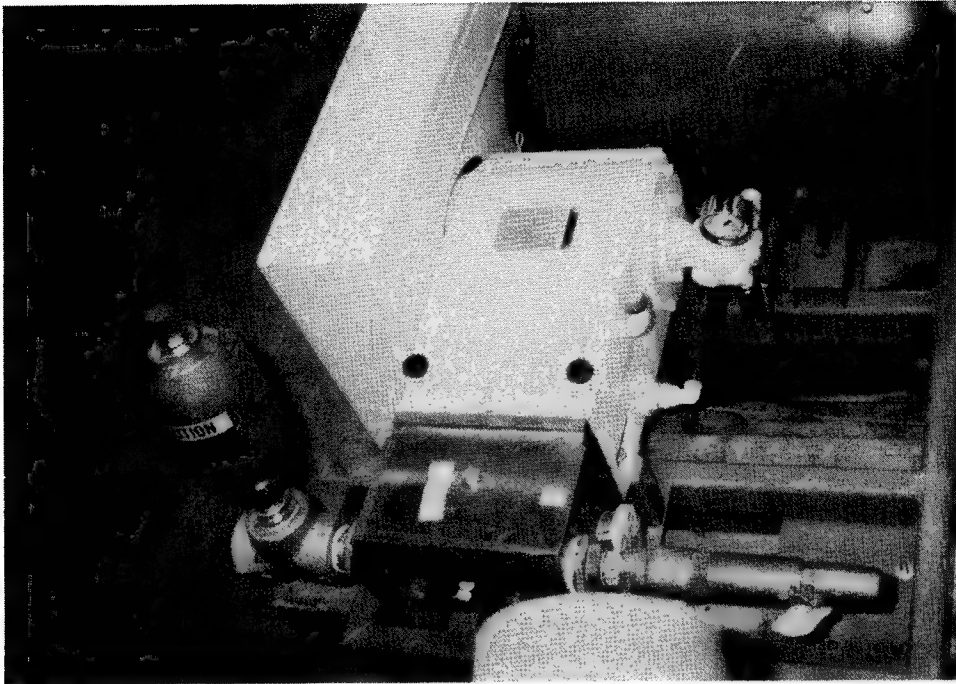
Figure 6. Ingersoll Rand pump (Greer 1-qt damper)

- (1) Pump was easily disassembled in accordance with the manufacturer's off-the-shelf manual.
- (2) No rust was apparent on internal or external surfaces.
- (3) A slight tear was apparent in the center cylinder rubber packing.
- (4) Crankshaft was difficult to access—motor was removed to access.
- (5) Packings, valves, pistons, belts, coupling, driver, and exterior of the pump were in good condition.

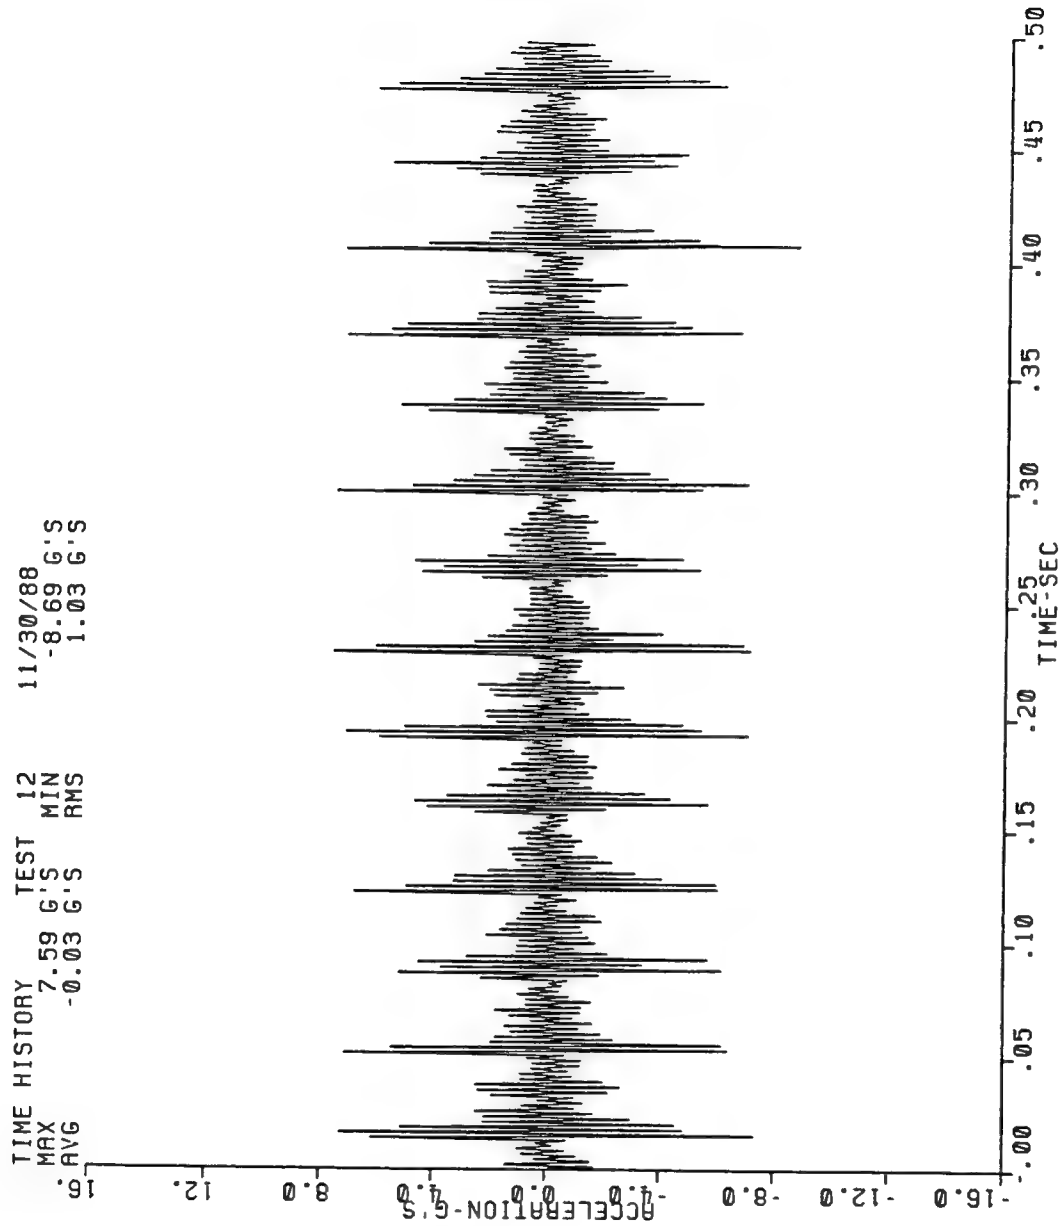
WHEATLEY PUMP, NO DAMP., V. ACCEL. PUMP,

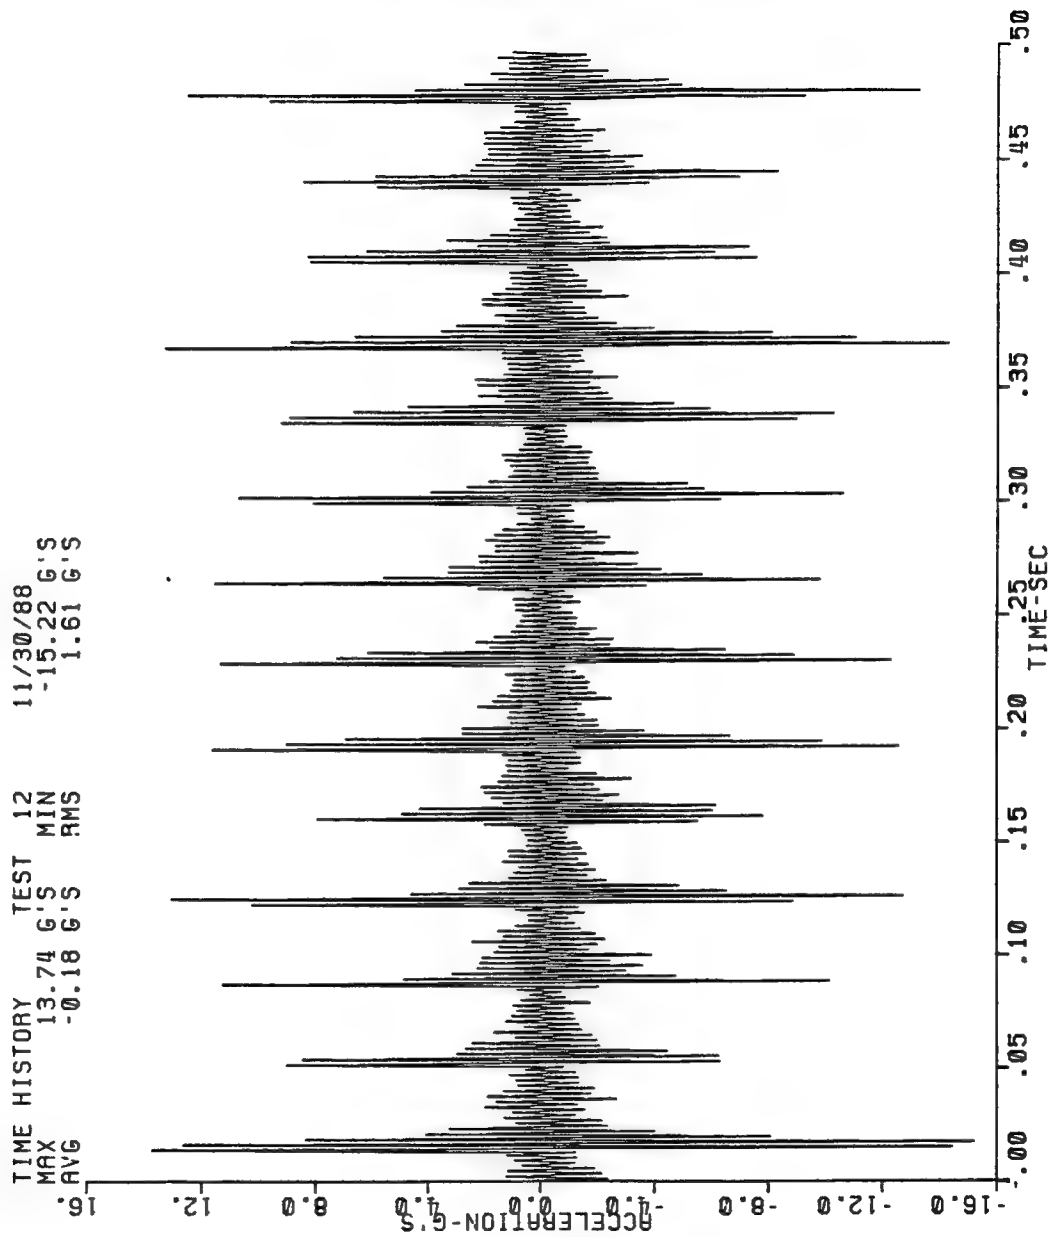
WHEATLEY PUMP, NO DAMP., H. ACCEL. FL.

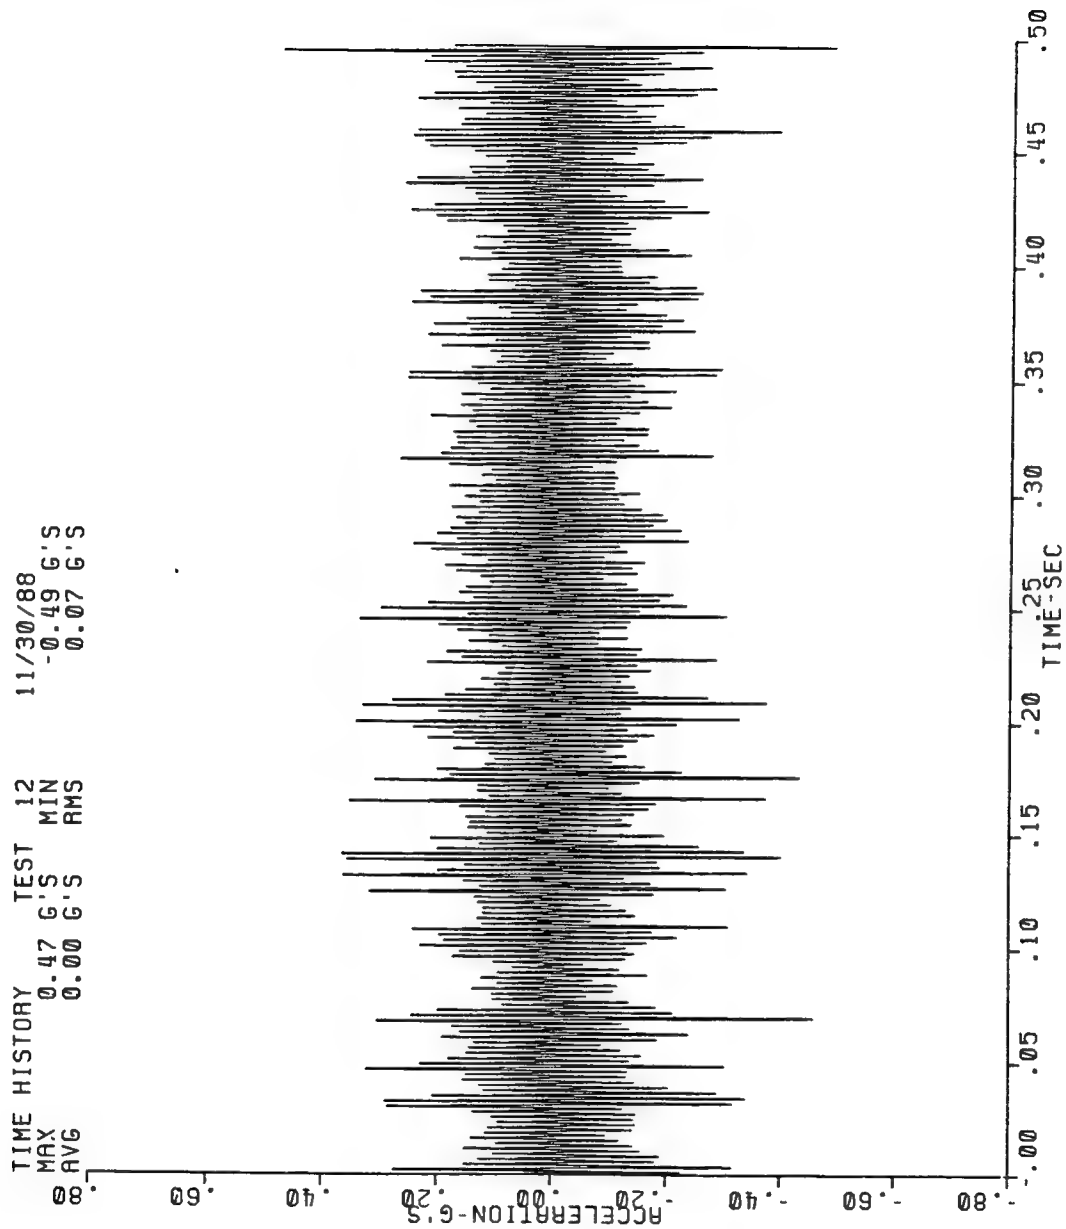
WHEATLEY PUMP, NO DAMP., V. ACCEL. FL.

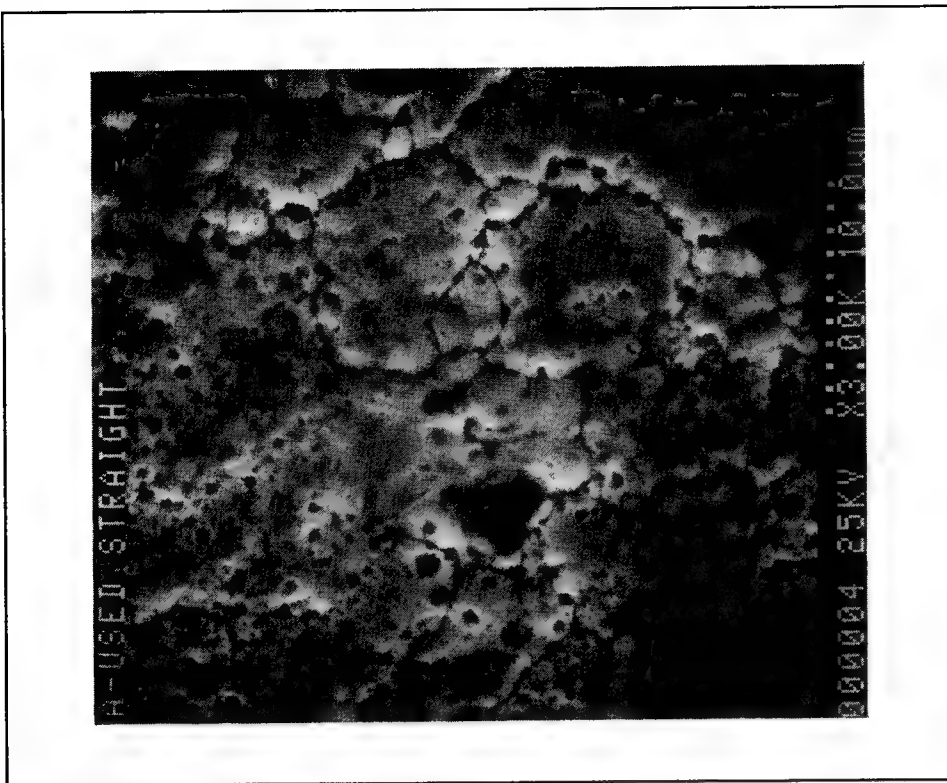
Figure E10. X3,000. Shows damage in straight pipe caused by saline solution. Pits average approximately 0.5 μm in diameter. "Valleys" that create boundaries for mosaic design have been deepened, and pits are in valleys

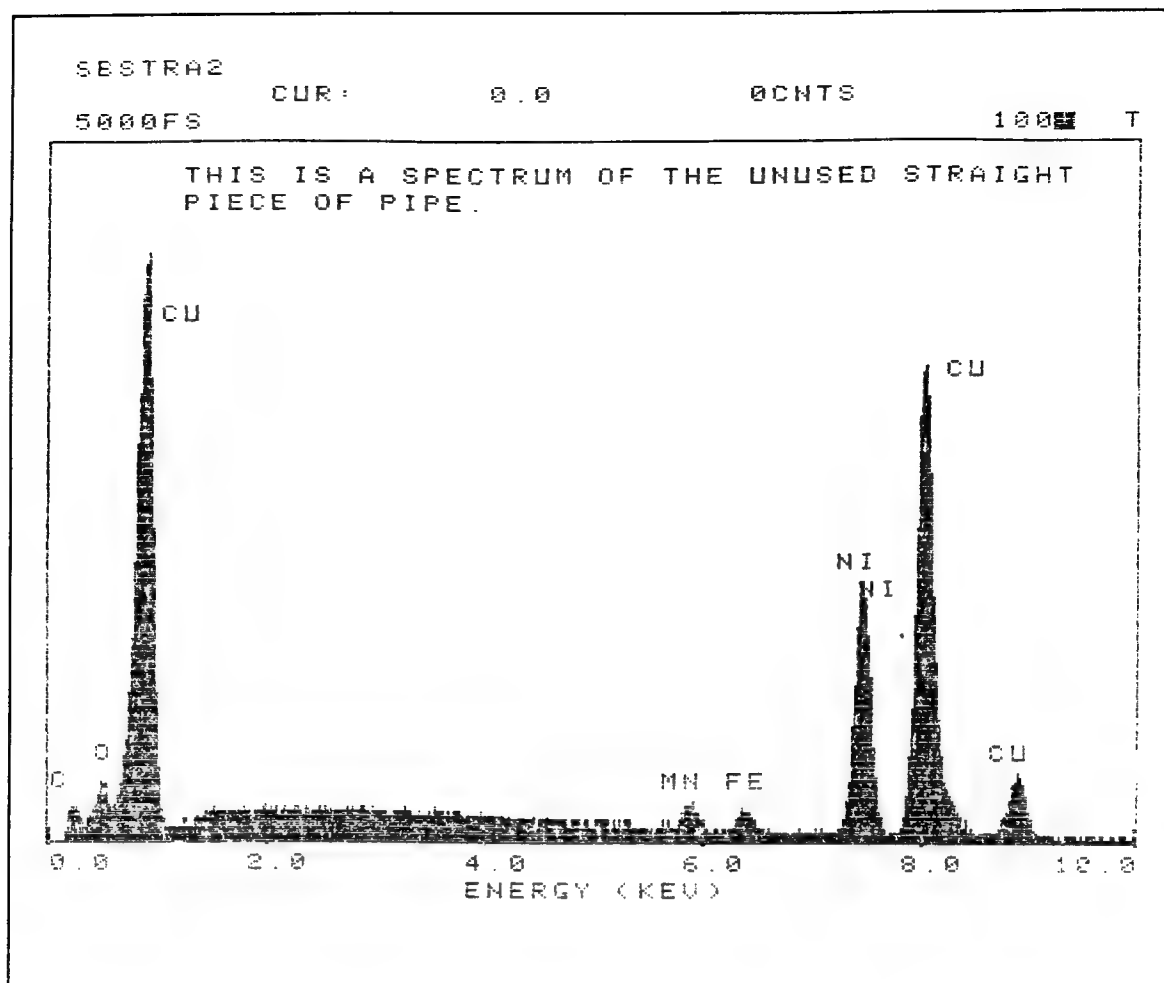
Figure E12. Spectrum of unused straight piece of pipe

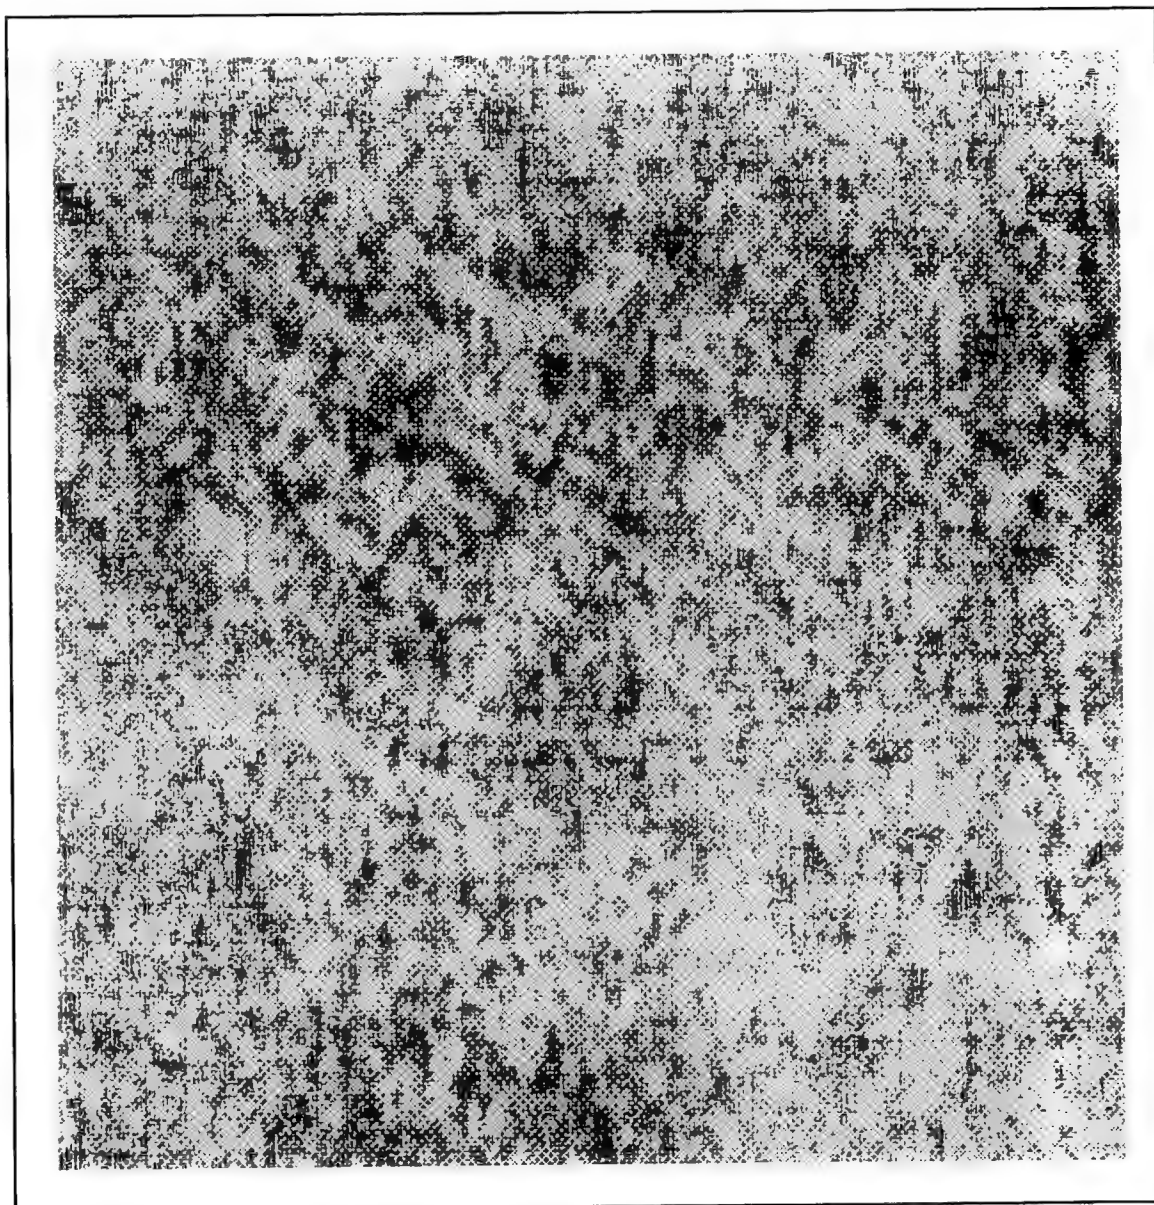
Figure E14. EDX high resolution X-ray map for copper in a tested pipe. Light areas show homogeneous distribution of copper in sample

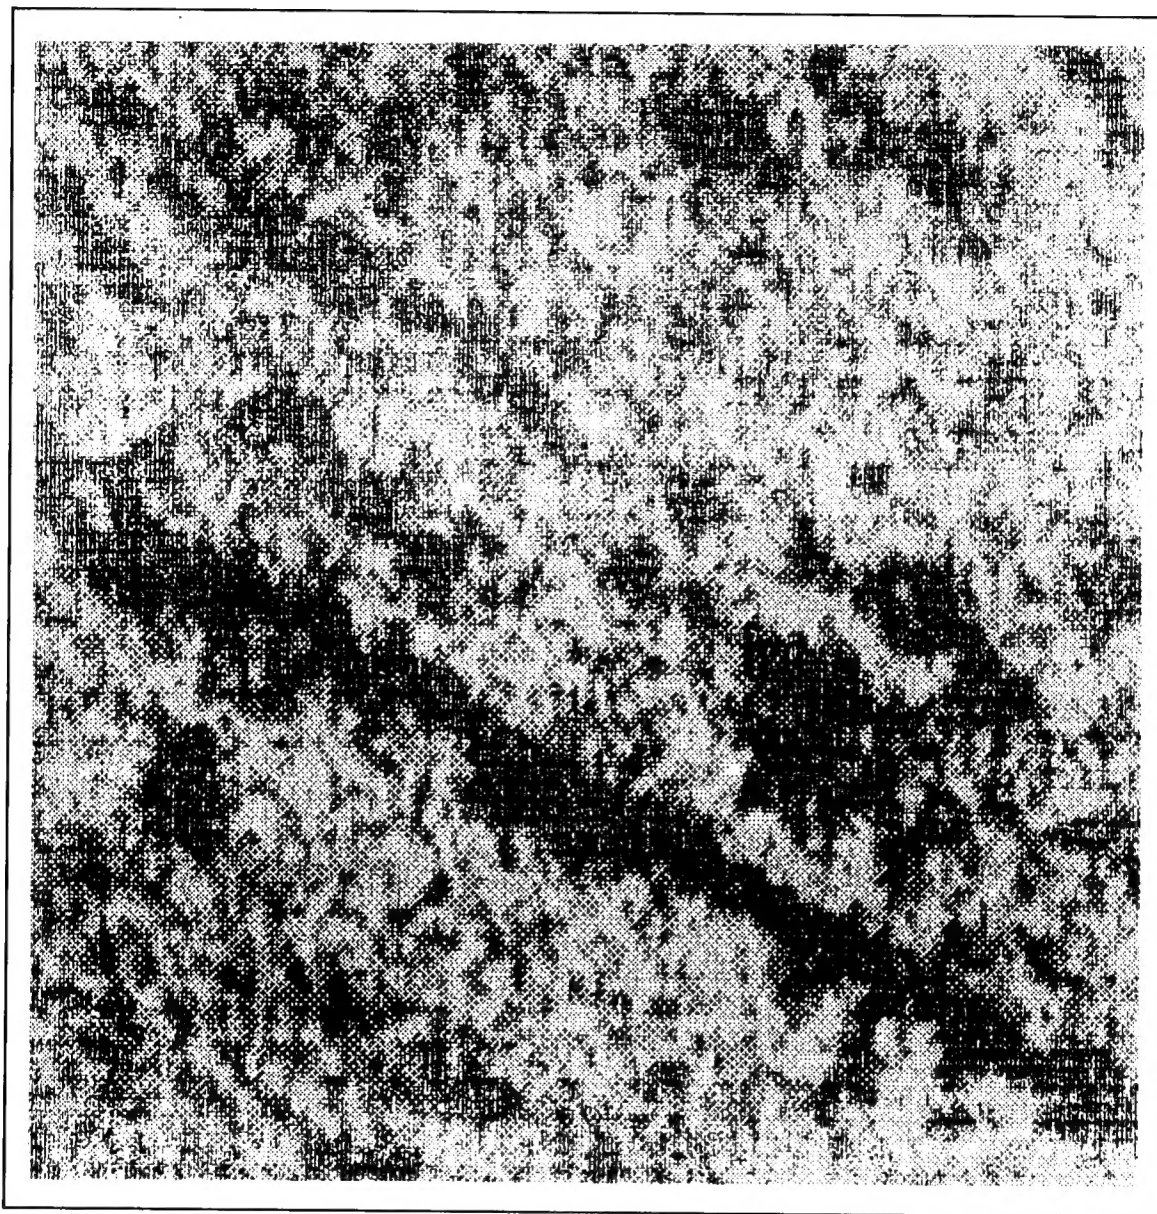
Figure E15. EDX high resolution X-ray map showing distribution of nickel. Light areas indicate concentrations of nickel in some areas

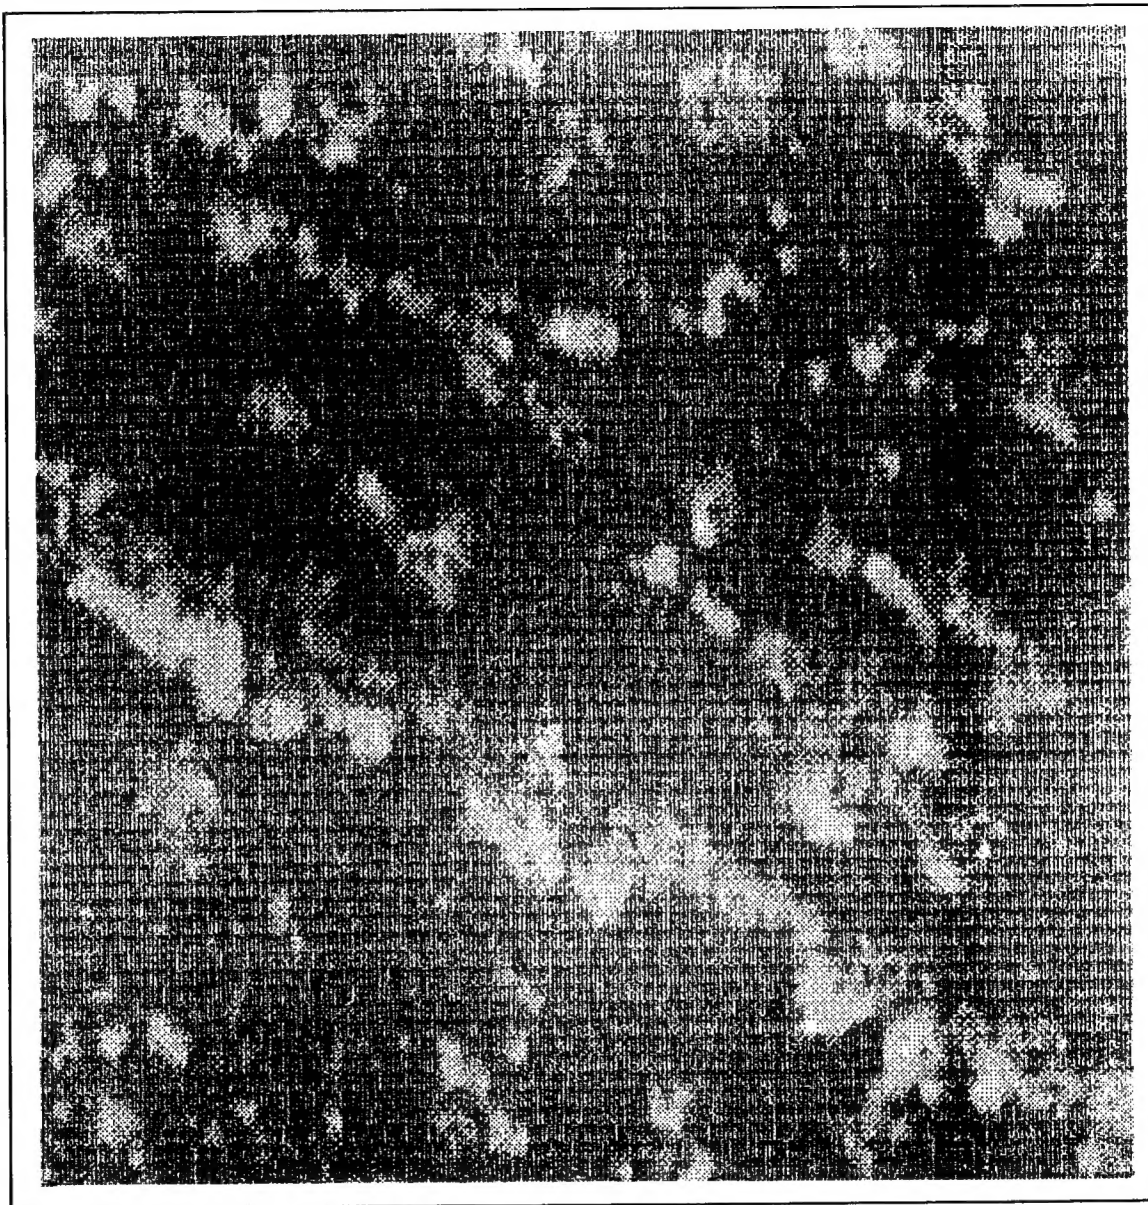
Figure E16. EDX high resolution X-ray map of chlorine. Orientation of concentration of chlorine is similar to that of nickel shown in previous figure
